**CT-97 Wilburne Farm
5550 Bayside Road (3737 Dalrymple Road)
Chesapeake Beach, Calvert County
EHT Traceries, Inc., Surveyor
February 26, 2003**

INVENTORY FORM FOR STATE HISTORIC SITES SURVEY

Wilburne house, barns, and tenant house.

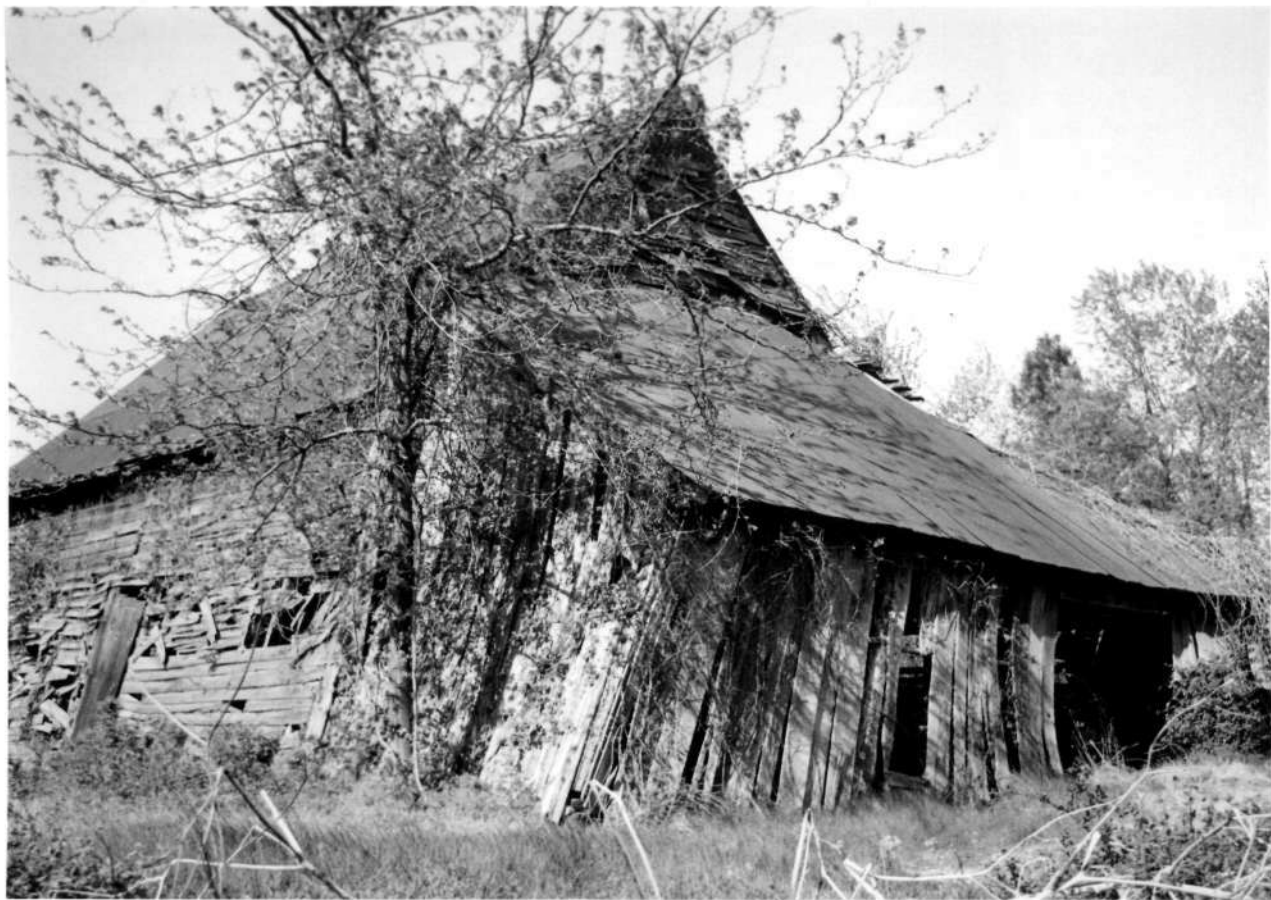
CT-97
Wilburne Farm
Barn

One of the remaining barns is in poor condition. It leans badly and the addition to the South end has collapsed. The other is in considerably better condition, although it too shows the stress of many years.

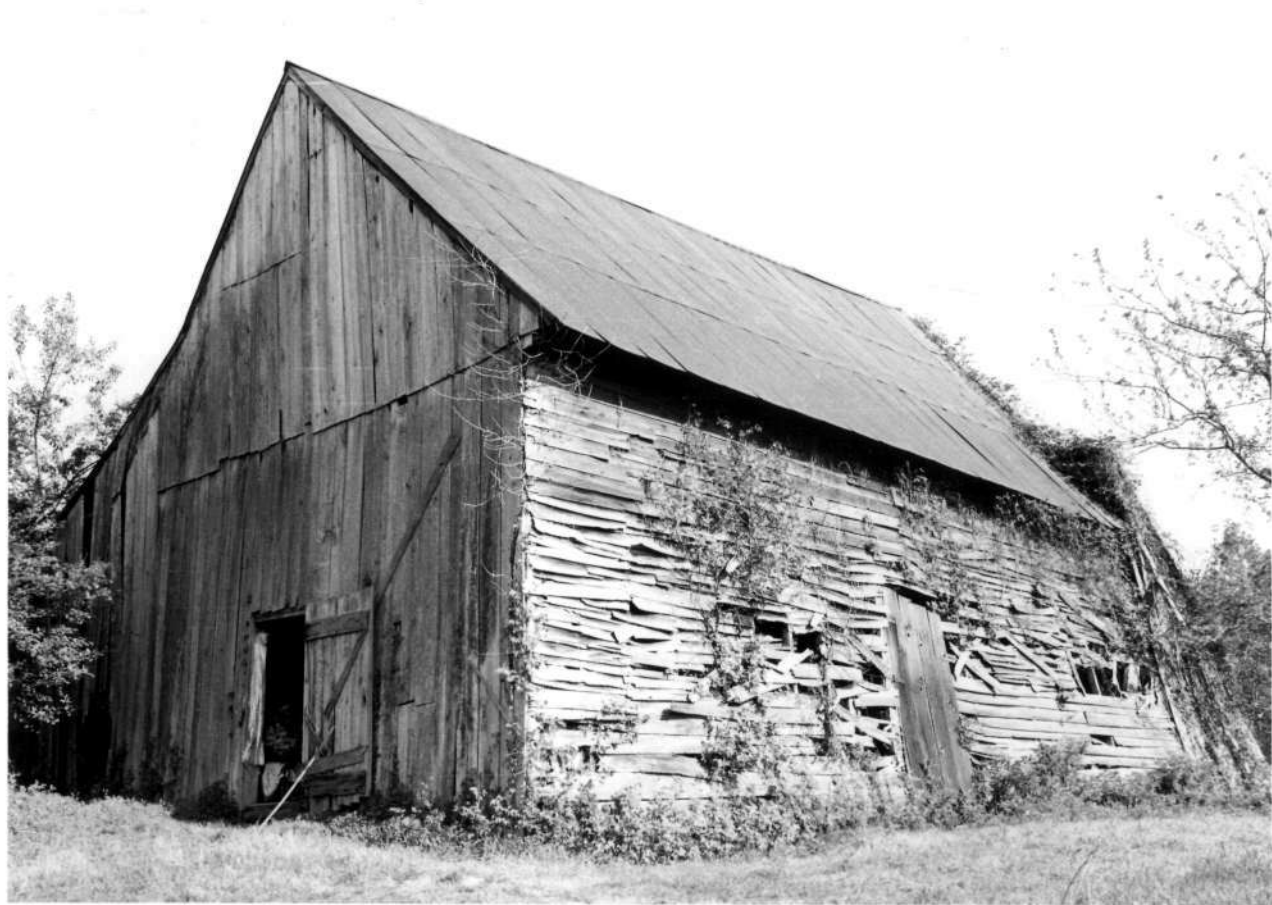
CT-97
Wilburne Farm
Barn #1
N.W. Corner

Barn #1: It will be noticed from the attached photograph that there is vertical siding on the north facade (most likely replacements) and horizontal siding on the west facade. Barns with horizontal siding (usually riven clapboards, 24" long 3" wide, feather edged and nailed to studs with cut nails) tend to be older in this area. Each side of the Wilburne barn has different siding. It is assumed that the west is original although it too has many patches. What was the east wall of the original barn is preserved by the shed addition on that side. Here the boards are 8" average width, butt end and feather edged. On some barns, horizontal siding is often overlapped on the ends as well as side edges, and clapboards on the south appear to be hand split and are C. 6" wide and 1/8" thick.

The degree to which the building is leaning makes measurements approximate, but it appears that the original barn measures 25' by 40' with 14' between the eaves and the ground. It is supported by a frame of hand hewn beams fastened by mortise and tenon with trunnels. Uprights and braces average 8" x 6 1/2 in thickness, foundation sills are 12" x 8 1/2" in thickness. The unusual feature of a tilted false plate has been noted in this barn.
